KLO-02-001

Mission STS-104
OV-104 Flight 24
Thermal Protection System
Post-Flight Assessment

March 2002

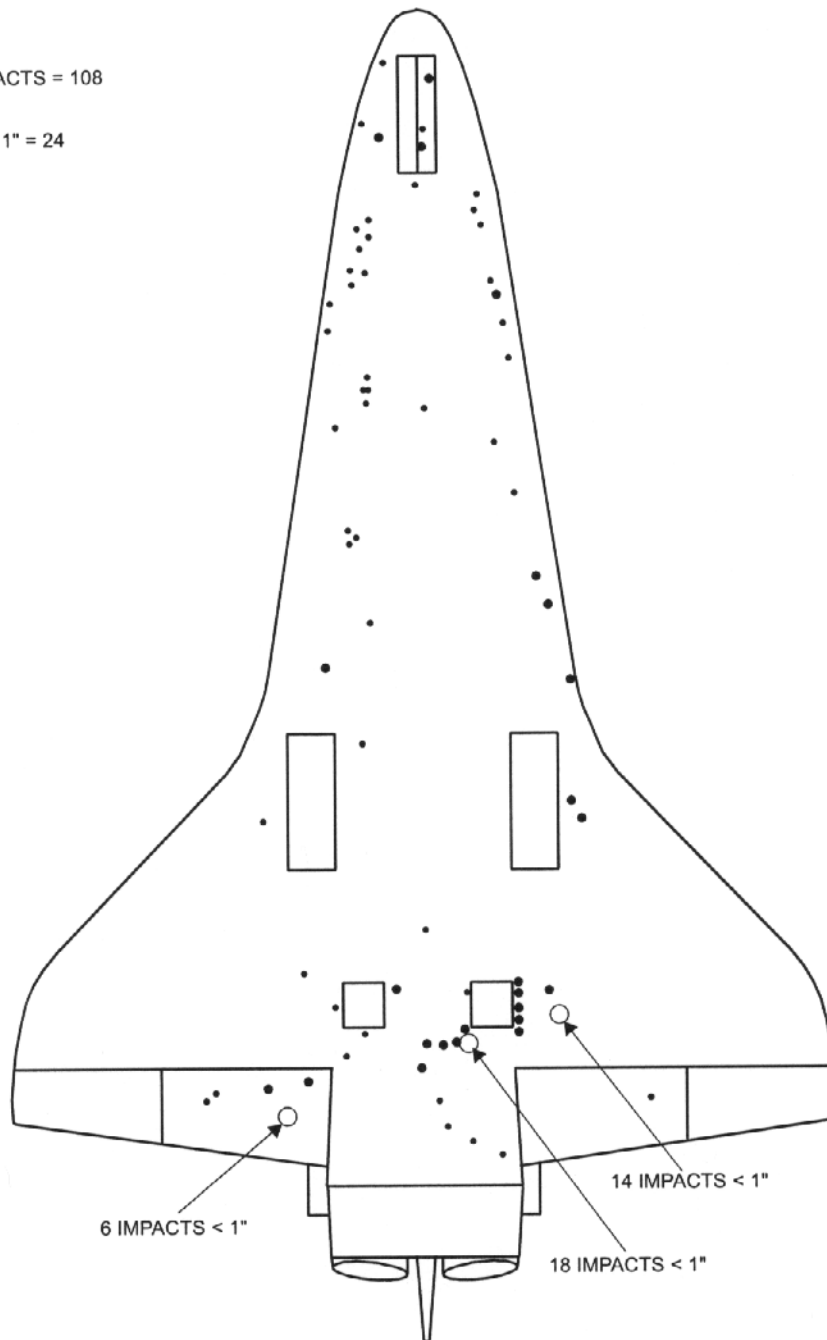
Figure 1. Lower Surface Debris Damage

TOTAL IMPACTS = 108

IMPACTS > 1" = 24

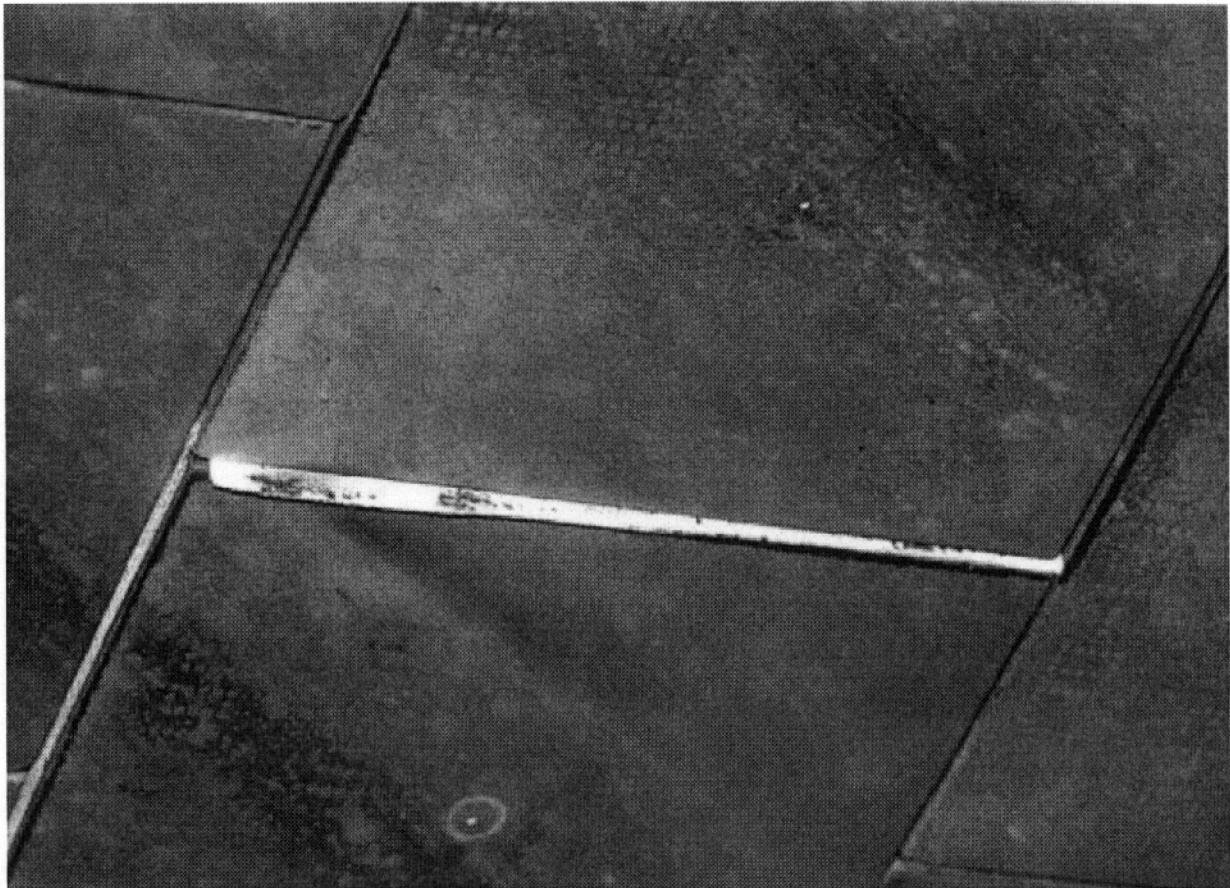
There was one protruding gap filler detected post flight (refer to [table 6](#)), and two Ames gap fillers were found on the ground under the NLGD. The STS-104 reentry summary data is provided in [table 7](#).

Photo 5. Left Hand Wing Protruding Ames Gap Filler (V070-191005-036/-069)

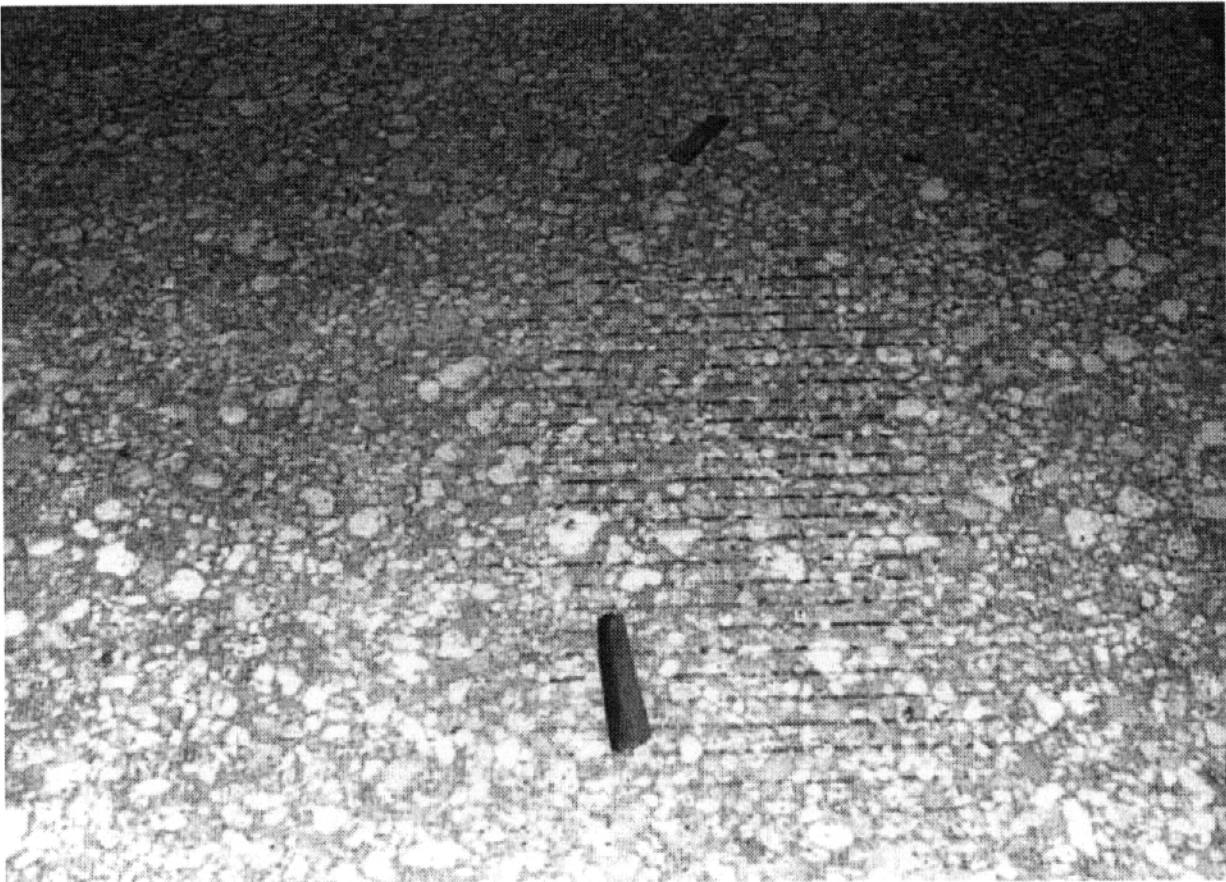
Two Ames gap fillers were found under the nose landing gear door (refer to [photo 6](#)). It is suspected that the Ames were installed to rework voids/flowpath locations along the NLGD at the interface to the thermal barriers. The bondline of this type of Ames rework is typically 1 inch in depth. Reentry heating degrades the bondline for this type of Ames rework such that when the NLGDs open some of the Ames fall off. Any remaining Ames still bonded to tile sidewalls are usually loose and if touched may fall off. This is not a concern post flight because turnaround processing and OMRSD requirements dictate removal of any remaining Ames post landing. Processing operations prior to flight reevaluate the interface between tiles and thermal barriers around the NLGD and rework poor compression/flowpath locations with new Ames installations, if required, to obtain a good seal.

Photo 6. Two Ames Gap Fillers Found on Runway Underneath the NLGD

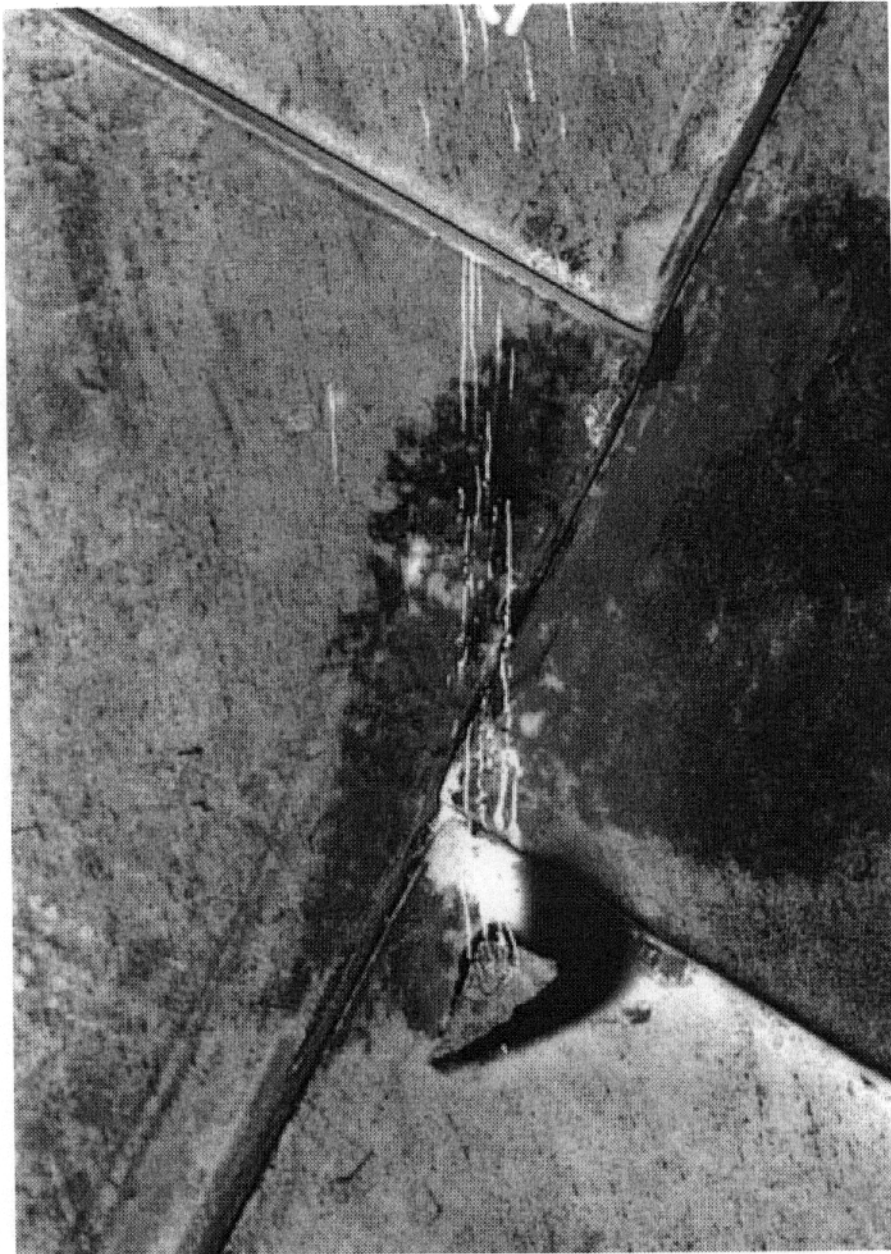
A discoloration that appeared to be a deposit on the OML of the V070-199714-068 tile was observed on the runway post landing. A closer evaluation by engineering revealed a tape deposit on the OML (refer to [photo 7](#)). Various other tile damages such as the V070-191003-244 tile (refer to [photo 8](#)) on the lower fuselage and wings were repaired utilizing established standard procedures.

*Photo 7. Tape Residue on Lower Right Hand LESS Carrier
Panel Number 8 Tile (V070-199714-068)*

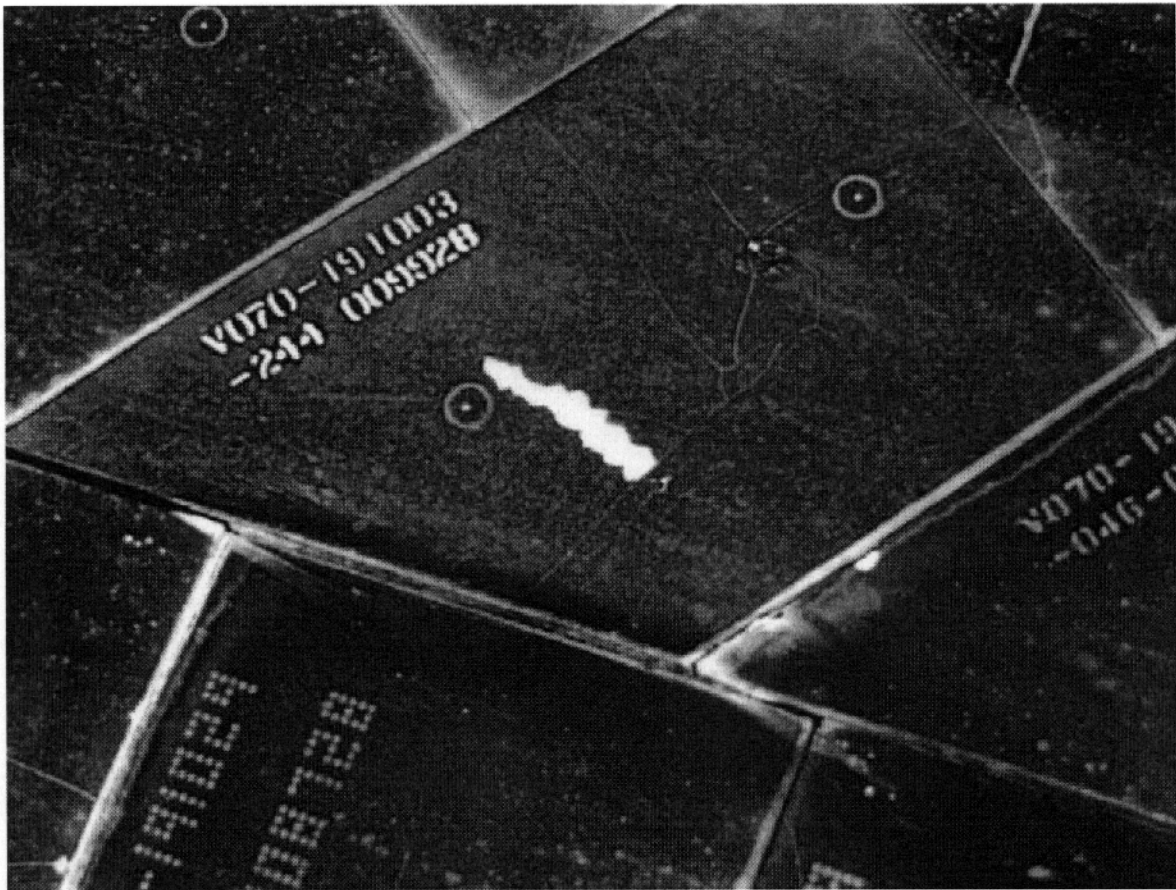
Photo 8. V070-191003-244 Tile OML Damage

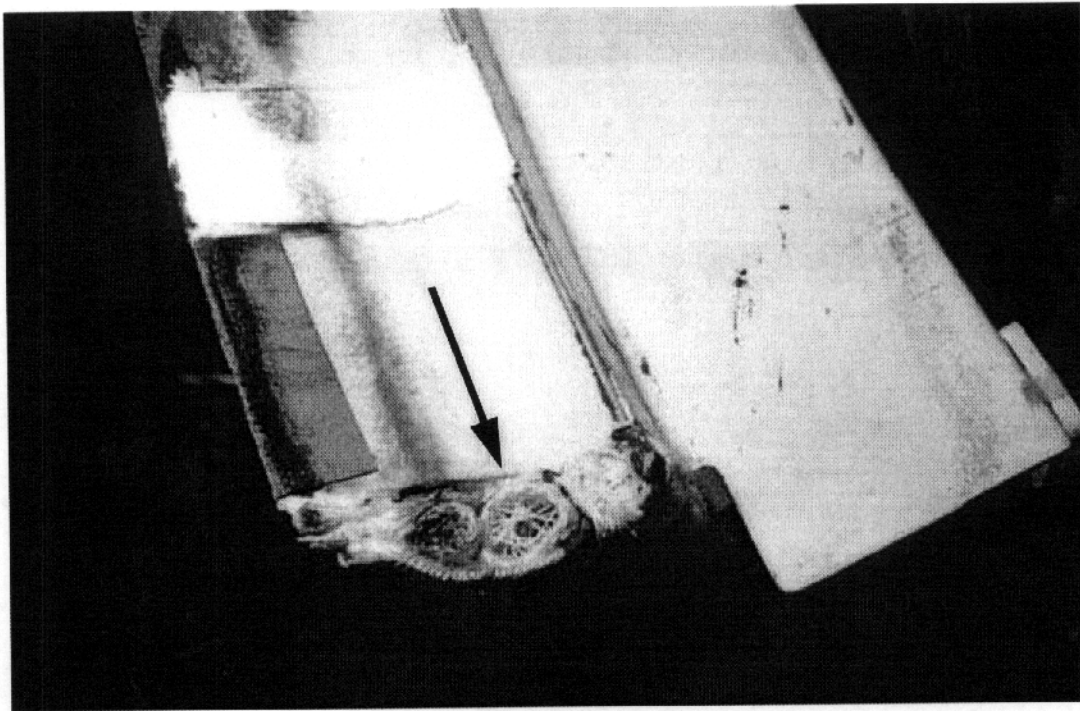
The assessment of the NLGD area post landing again revealed that the V070-398374-001 centerline primary thermal barrier had the inner filler batting either compressed or missing from the forward end of the barrier (refer to [photo 9](#)). As noted in previous reports, this is a condition that has been observed on other post-landing assessments of this and other vehicles. The contributors to this condition are the method of close-out for the end of the thermal barrier, and the direct impingement of turbulent 200+ mph airflow to the forward end of this thermal barrier. The end of the thermal barrier is closed out by performing a wagon wheel stitch at the end of the part for each spring tube, which ultimately allows the filler batting to be visible around/through the stitching. This configuration at the forward end of the thermal barrier, when entering the airflow during final approach landing speeds of the vehicle immediately upon opening of the doors, yields the noted condition. This repetitive condition, which requires the barrier to be removed and replaced, prompted a review of the design for a possible change. Boeing LSS engineering and TPSF personnel worked together to build two prototype parts to demonstrate two different ways to close out the end of the V070-398374-001 thermal barrier to help mitigate/eliminate the direct airflow impingement on the internal batting at the forward edge of this barrier from occurring. The prototype parts yielded successful fabrication results, and a briefing was presented at the TPS PRT in September 2001 by Boeing LSS to recommend a design change that utilized a fabric end cap covering for the noted thermal barrier. The recommended design change was approved and engineering was released in December 2001. Post landing of mission STS-104 (flight 24), the thermal barrier was removed for compressed/missing batting, and the redesigned thermal barrier with the fabric end cap cover was installed per the new drawing configuration during the processing flow for flight 25 of OV-104 (mission STS-110). Flight 25 of OV-104 will be the first vehicle/mission to fly the new configuration.

Photo 9. NLGD Forward Centerline Thermal Barrier (V070-398374-001)

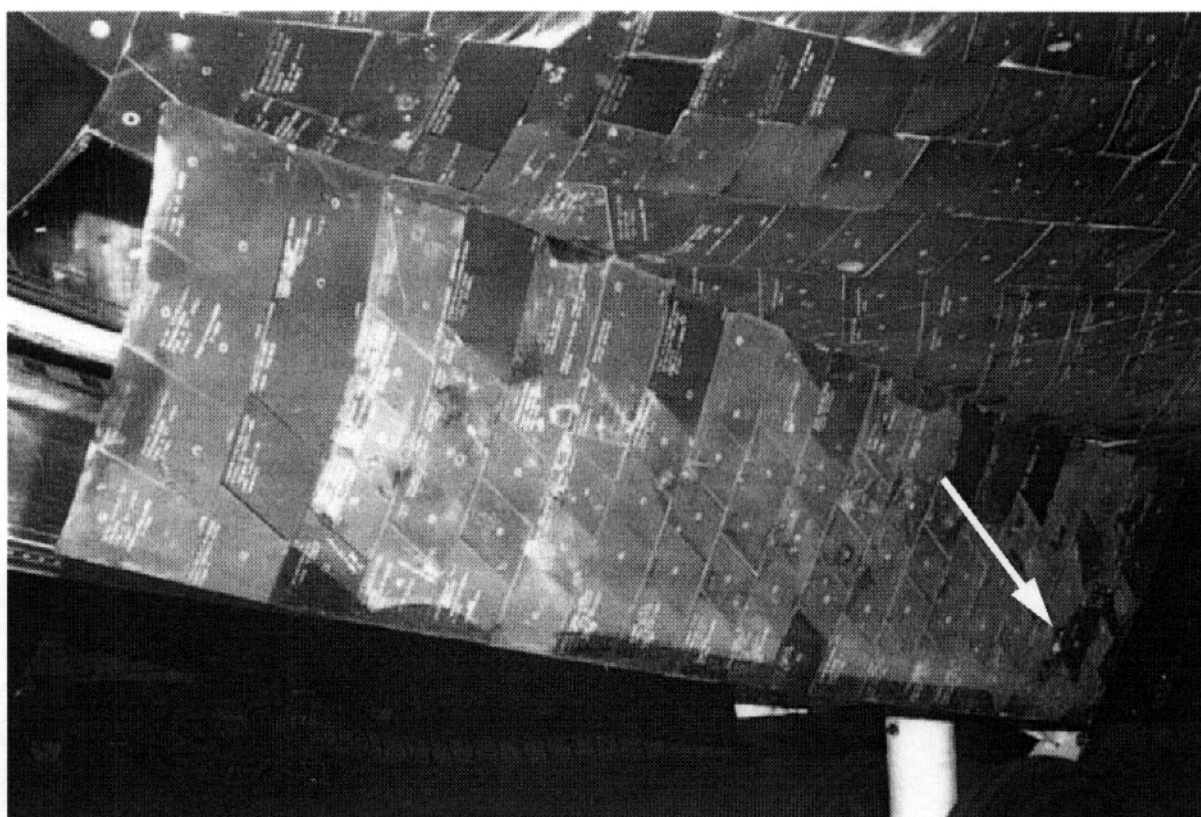
Evaluation of the chin panel area and the V070-399441-044 chin panel gap filler during runway inspection found the gap filler to be in nominal condition. The V070-391025-035 NLGD door tile was removed and replaced due to large impact damage ([photo 10](#) and [photo 11](#)). All other TPS components in the NLGD area appeared nominal (refer to [table 10](#) for thermal barrier replacement history).

Photo 10. Damaged OML Tile (V070-391025-035), Overall View

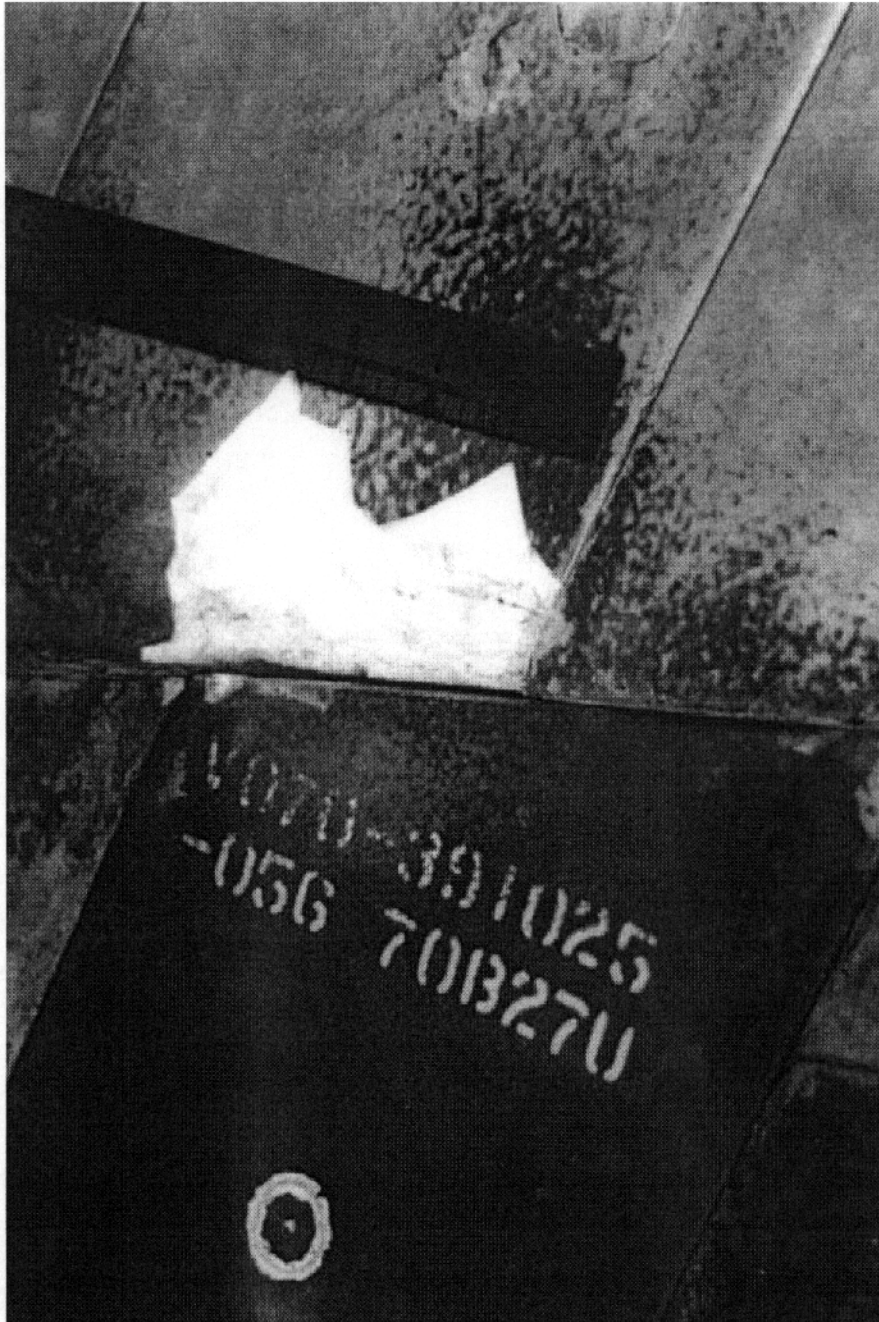
Photo 11. Damaged NLGD OML Tile (V070-391025-035)

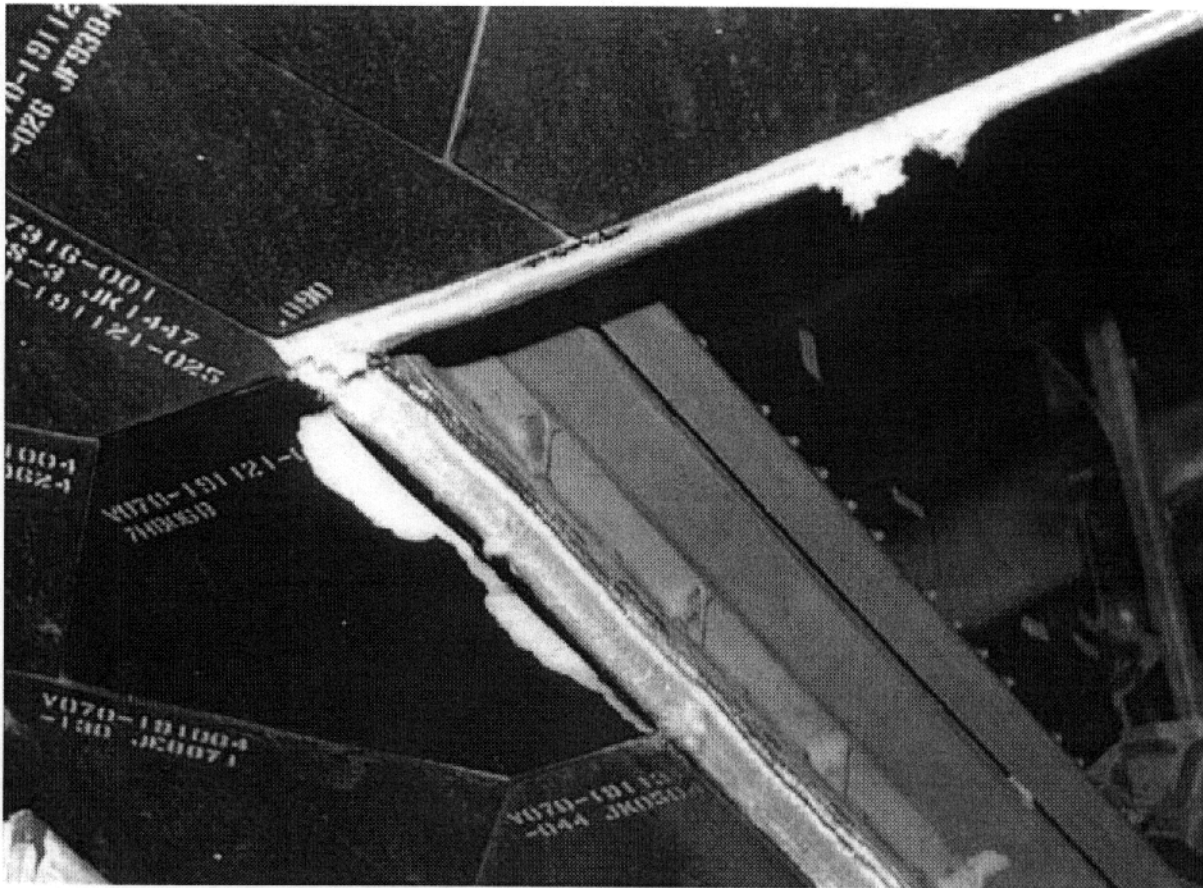
The performance of the TPS in the MLGD area appeared nominal. All of the periphery tiles were intact with the exception of the V070-191121-024 tile which incurred a large damage along the tile edge approximately 3.5 inches in length (refer to [photo 12](#) and [photo 13](#)). The tile, located at the forward outboard corner on the right hand MLGD on the structure side, was removed and replaced as a result of the tile damage. Numerous MLGD periphery thermal barriers exhibited typical wear. Breaching/tearing of the outer cover fabric (refer to [photo 14](#)) occurred on 13 barriers (8 on the right side and 5 on the left side) which required removal and replacement with new parts. Refer to table 11 below for thermal barrier replacement history.

Photo 12. Right Hand MLGD OML Tile (V070-191121-024) Damage

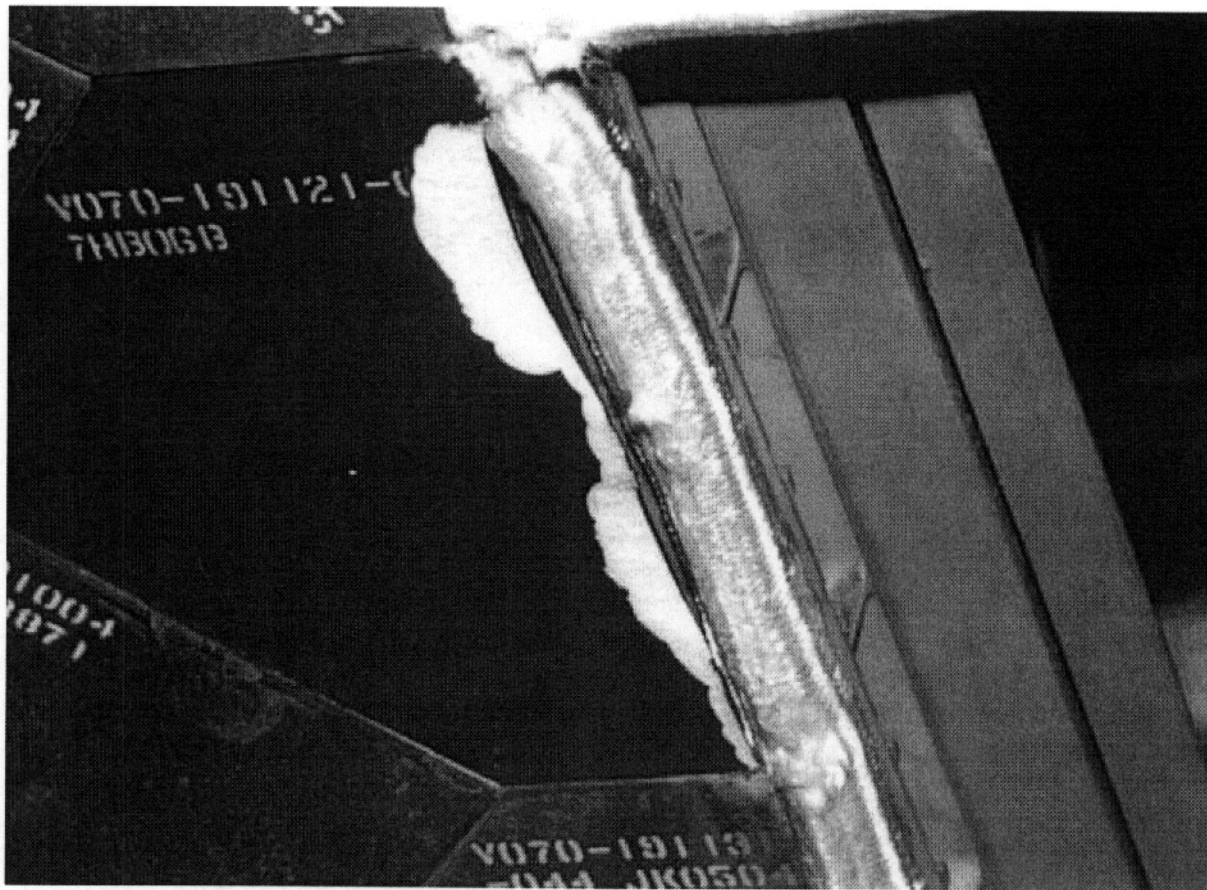
Photo 13. Right Hand MLGD Tile and Thermal Barrier Damage, Close-up View

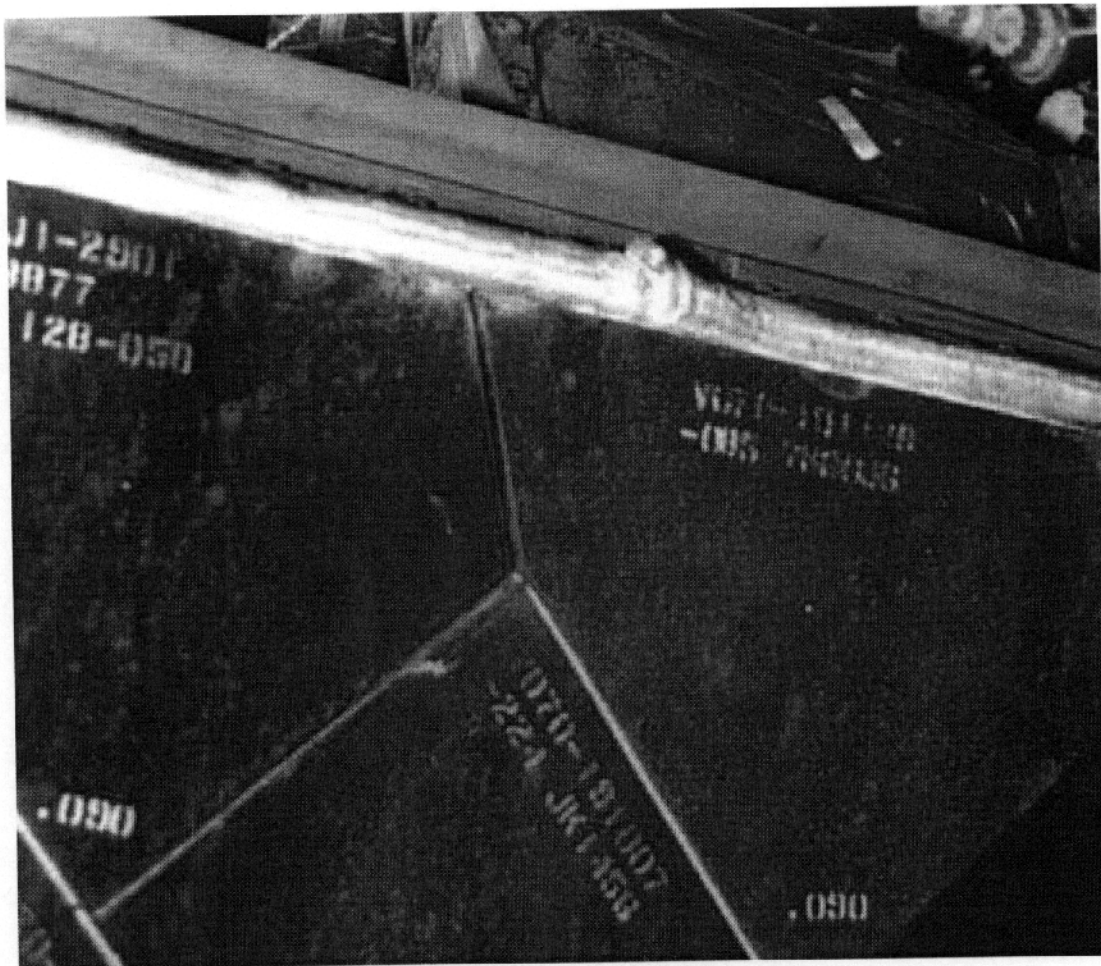
Photo 14. Typical Wear and Tear for MLGD Thermal Barriers

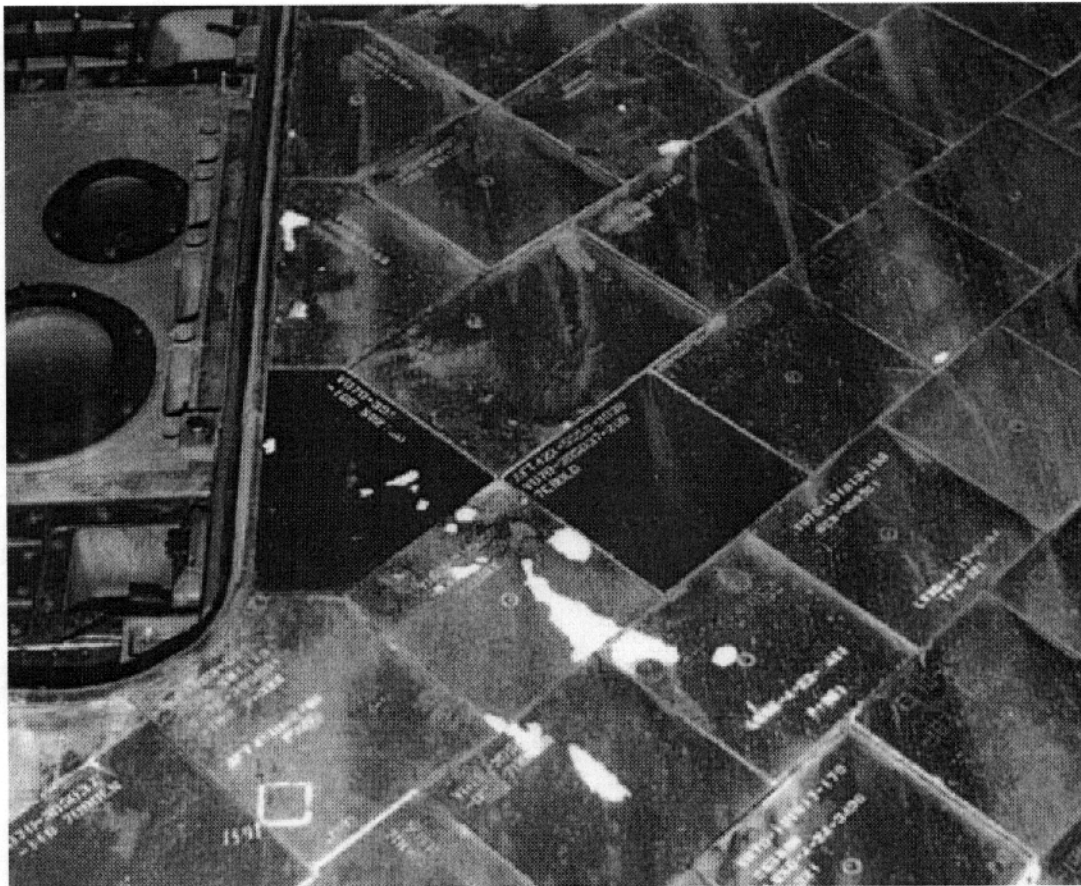
The post-flight evaluation of the periphery thermal barriers for both the left and right hand ET doors revealed that the barriers were degraded, brittle, or had tears in the OML fabric, and the black RTV exhibited a “chalky” appearance typical of flown ET thermal barriers (refer to [photo 15](#)). The entire set of ET thermal barriers on OV-104 post flight 24 have accumulated two flights of the maximum three-flight limit.

*Photo 15. Aft Outboard Corner Left Hand ET Door
Thermal Barriers and Tile Damage, Overall View*

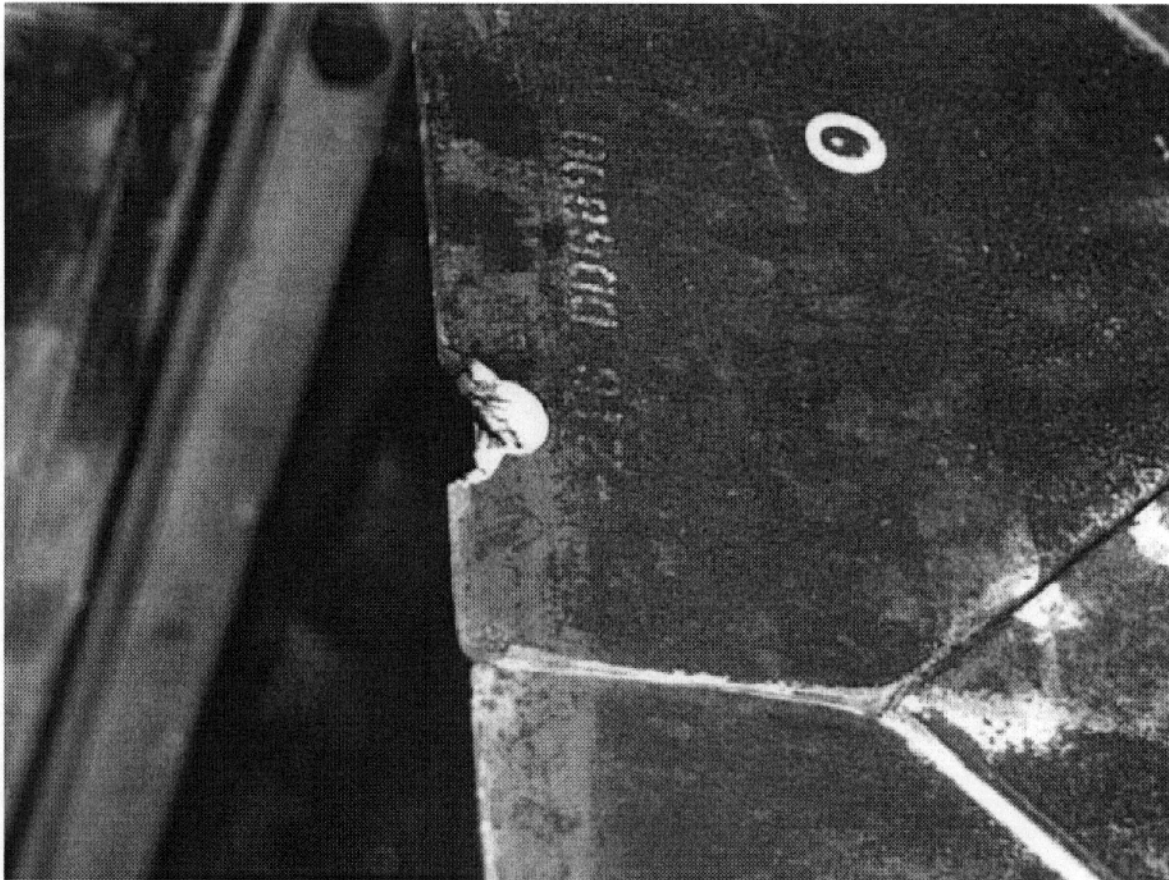
Several damages to tile in the ET door area were incurred during the STS-104 mission. Evaluation of the beveled lip damage on the V070-395055-216 tile determined that the appropriate action was to remove and replace the tile (refer to [photo 16](#)). The V070-395055-206 tile (refer to [photo 17](#)) sustained a minor corner damage at the interface to the latch fitting. This damage was within criteria suitable for rework utilizing a standard procedure putty-type repair. The V070-395037-153 tile (refer to [photo 18](#)) and approximately six tiles outboard of the right ET door cavity (refer to [photo 19](#)) and six tiles at the aft outboard corner of the left ET door cavity (refer to [photo 15](#)) sustained impact damages that were also within criteria suitable for rework utilizing standard repair procedures. A discoloration observed on the Inconel fingers of the leading edge right ET door (refer to [photo 20](#)) was evaluated by engineering for degradation. Evaluation determined no degradation/slumping of the fingers had occurred. The discoloration was cleaned off utilizing approved specification solvents. All other components of the ET door area were in typical condition.

Photo 16. Damaged Leading Edge Tile (V070-395055-216) on Right Hand ET Door

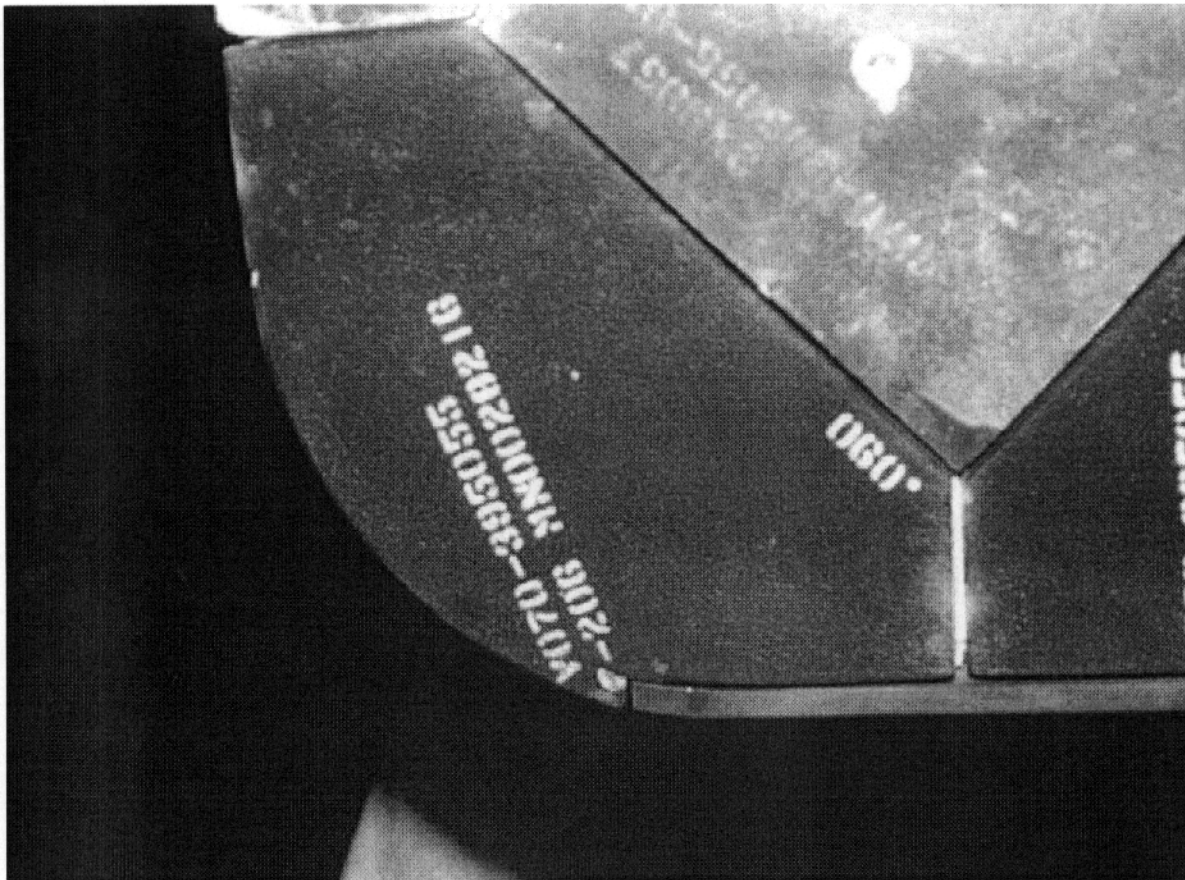
Photo 17. Damaged Corner Tile (V070-395055-206) on Right Hand ET Door

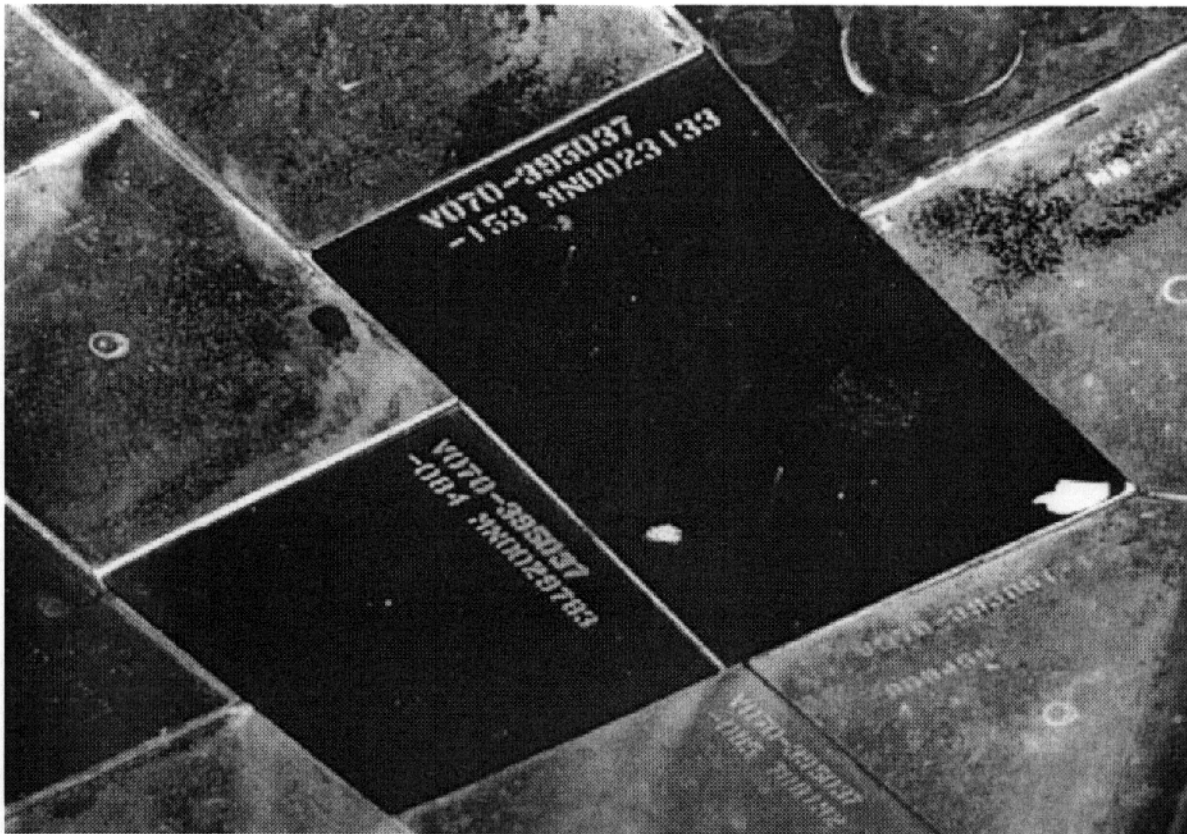
Photo 18. OML Damage on Tile (V070-395037-153)

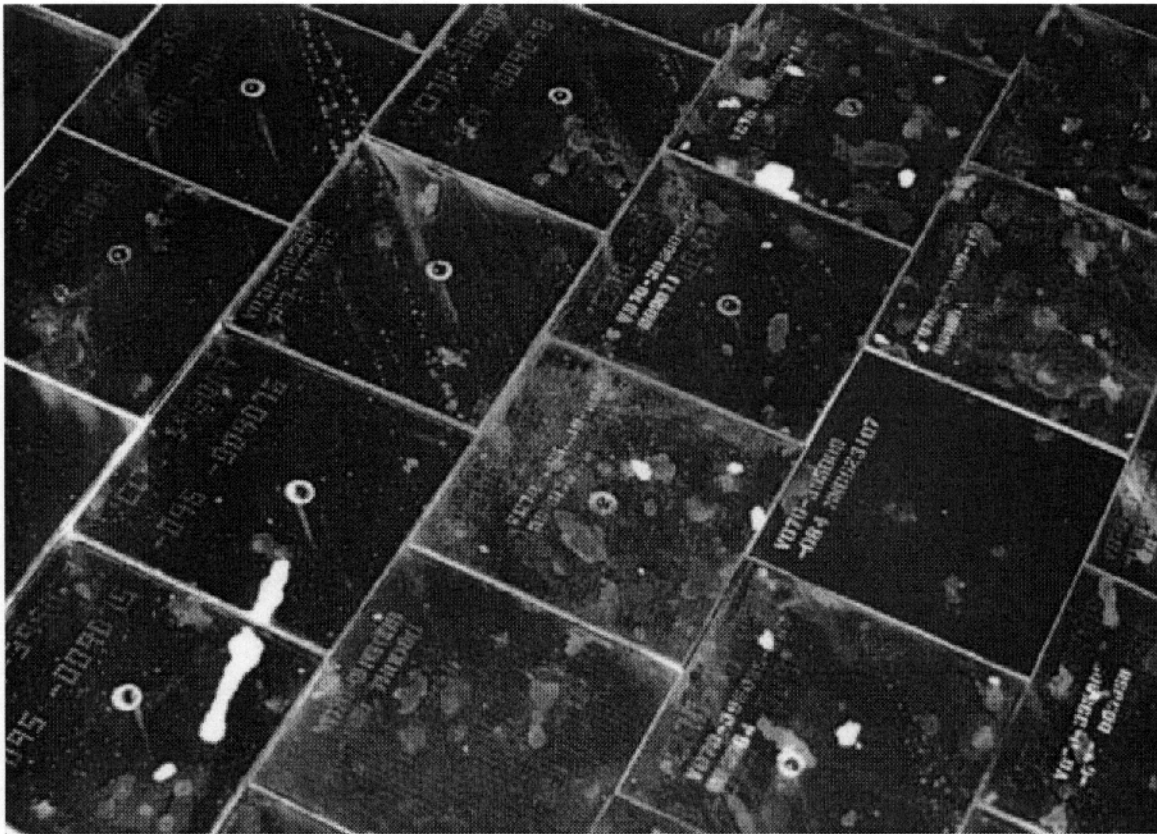
*Photo 19. Acreage OML Tile Damage Inboard of Left
Hand Aft Corner of ET Door Cavity*

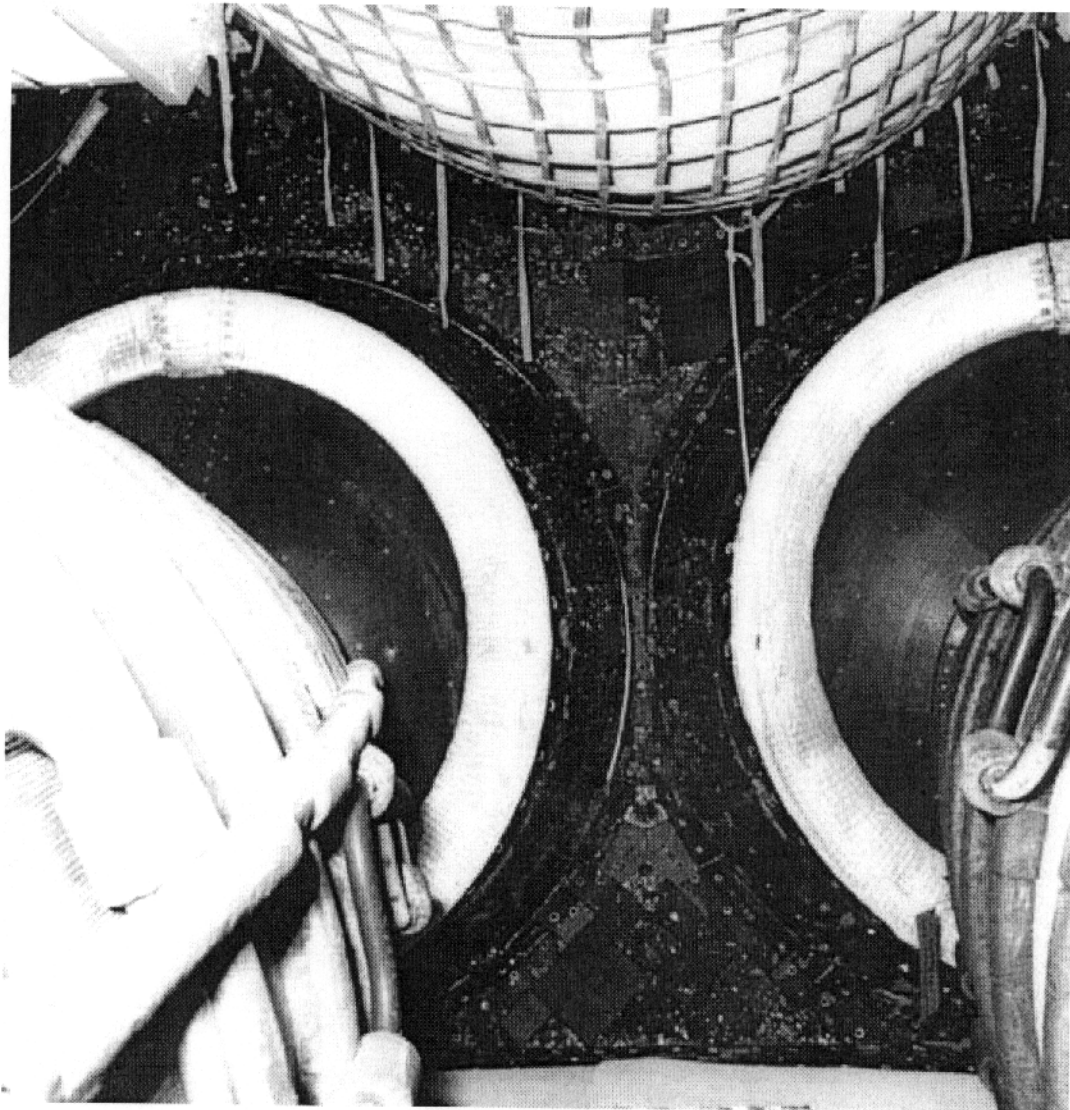
Photo 21. Peppering Condition on Aft Base Heat Shield

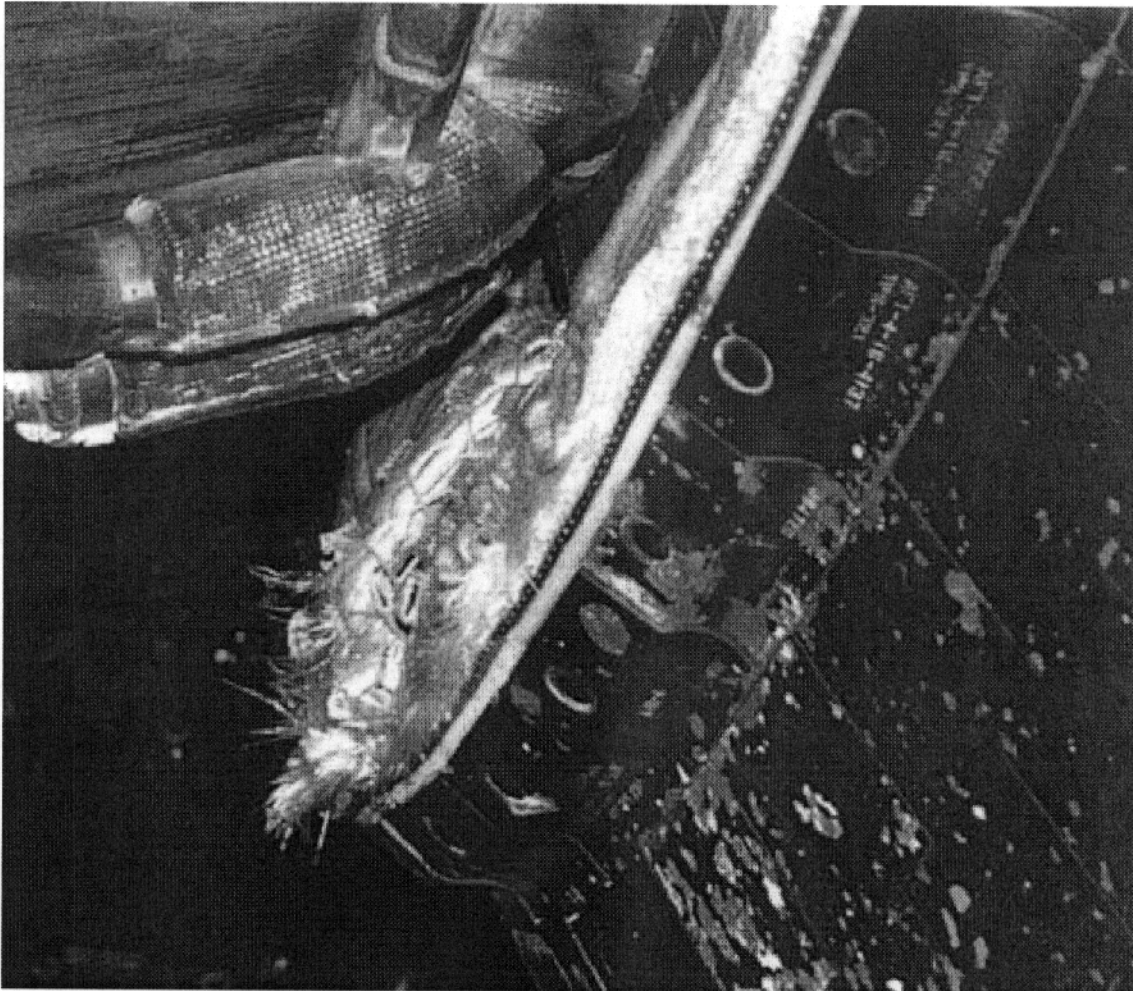
Photo 22. SSME Number 1 Damaged Dome Heat Shield Blanket and Pillow

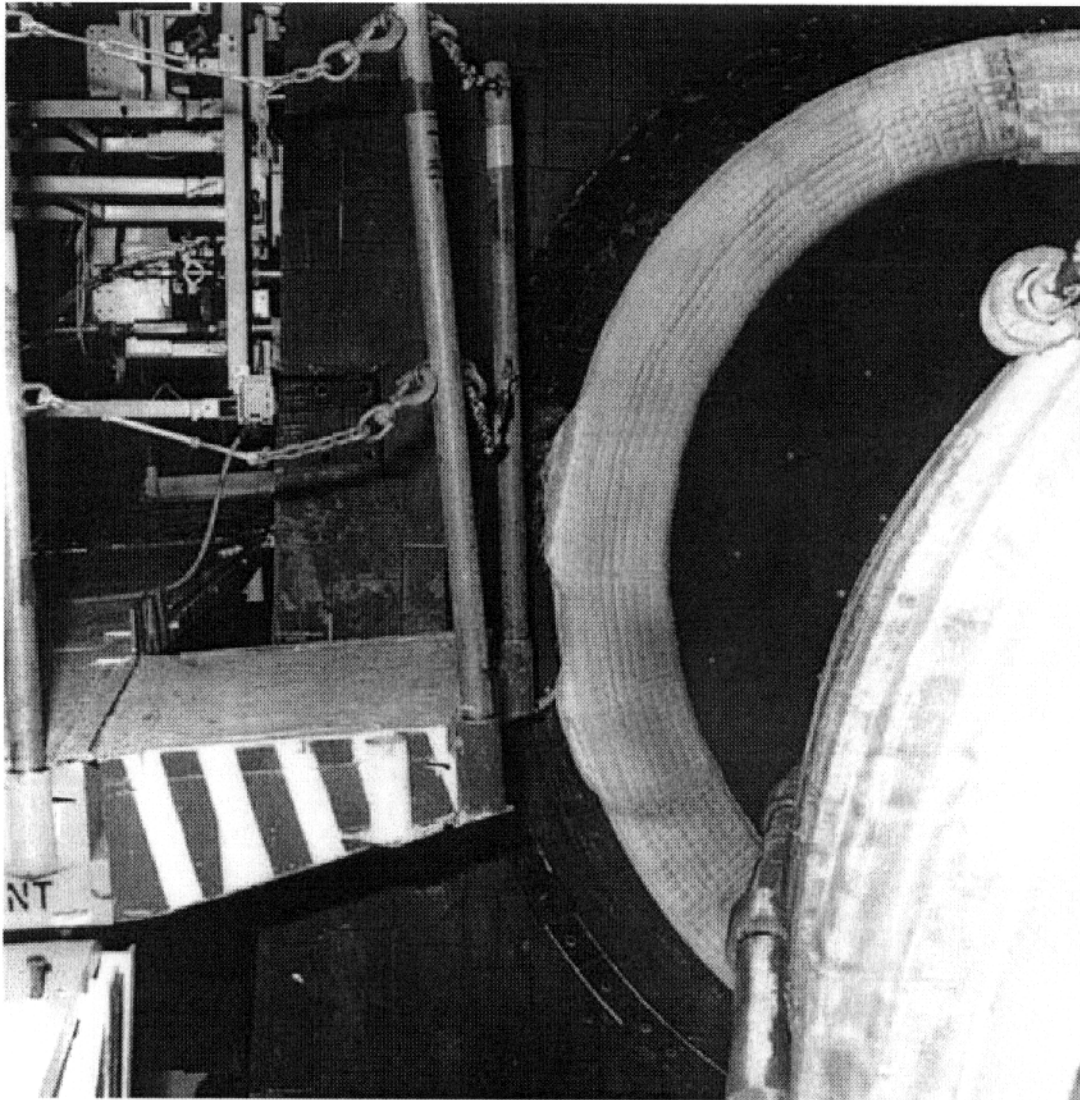
Photo 23. SSME Number 2 Damaged Dome Heat Shield Blanket
